**The seismic vulnerability of buildings in the central
zone of Peru through the application of the rapid
visual detection method**

The Seismic Vulnerability of Buildings in the Central Zone of Peru through the Application of the Rapid Visual Detection Method

Faculty of Engineering, Universidad Continental, Perú

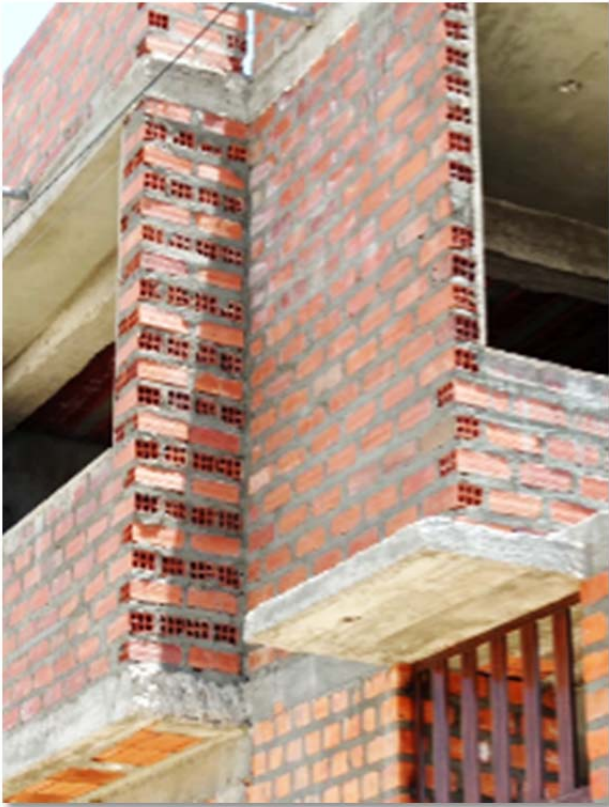
Figure 10. Use of hollow bricks as a structural wall

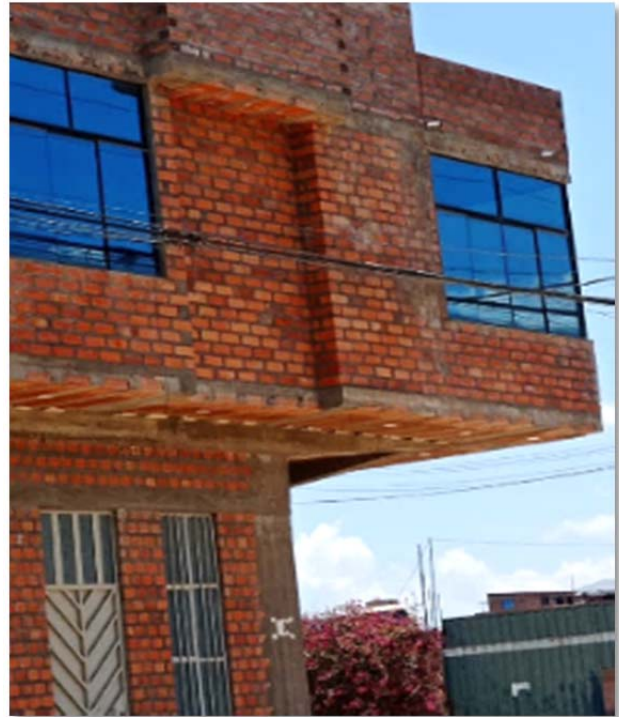
Figure 12. Abrupt changes in stiffness of floors

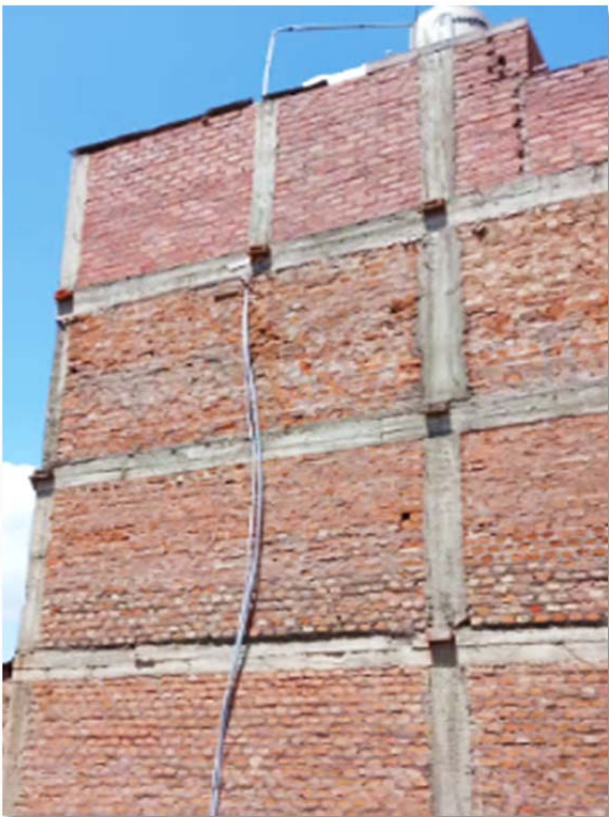
Figure 11. Absence of confinement elements
