Tesis

**Self-Built Houses in a Peruvian Andean City:  
Seismic Vulnerability and Seismic Behavior**

Huancayo, 2023

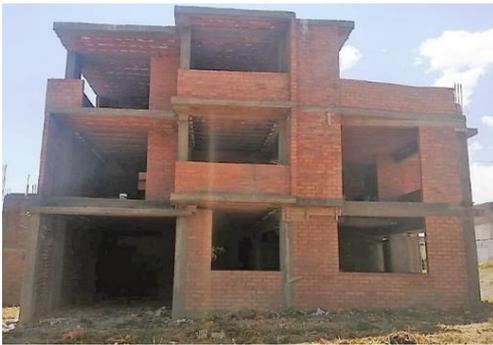
**Figure 19.** Presence of openings in load-bearing walls.

Upon conducting the seismic vulnerability assessment of the examined dwellings, various construction process inadequacies were identified: The presence of openings in load-bearing walls compromising their rigidity in the constructed direction (Figure 19), utilization of tubular bricks instead of hollow-solid bricks, exceeding the maximum permissible thickness of the joint between tubular bricks prescribed by the Peruvian Standard E070 [31], presence of pipes within load-bearing walls impeding their confinement, and placement of sanitary installations in the ribbed slab adversely impacting the reduction of beam cross-sections. Furthermore, the results obtained through on-site observations using the data collection form, which assesses seismic vulnerability, closely resemble those found in countries experiencing population growth and utilizing similar construction materials.

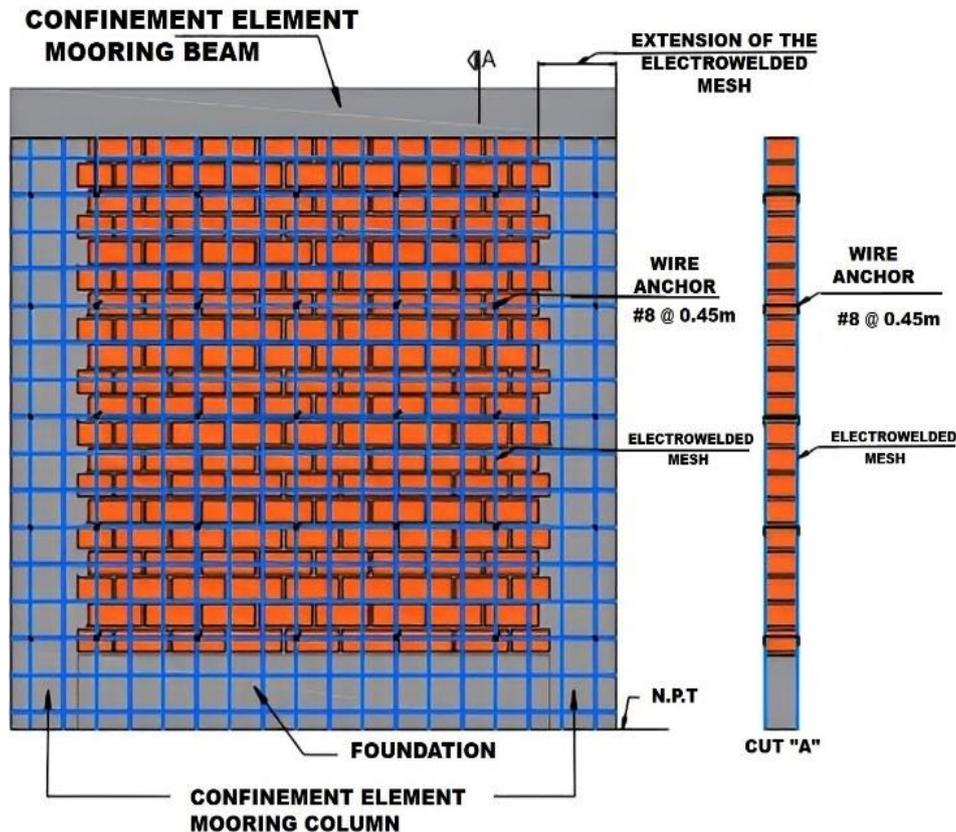
Figure 20. Welded mesh [35]

Furthermore, it was observed that most of the examined dwellings exhibit tendencies towards crack formation in both directions and fall short of meeting shear verification at the first level of their frame structures with infill masonry walls. As a result, an alternative approach has been proposed, involving the reinforcement by utilizing welded wire meshes, as depicted in Figure 20. This method entails encasing 0.45 cm diameter steel rods spaced at 15 cm intervals with mortar, employing volumetric proportions of cement to sand 1:4. The implementation of this technique transforms diagonal cracks into minor fissures and elevates the lateral load resistance by 40% [33]. Conversely, the use of plastic meshes derived from cement bags, with 25 mm wide strips enwrapped around the frame structures with infill masonry walls and a plastering surface featuring a thickness of 1 cm using cement to sand proportions 1:4, results in a remarkable improvement of over 90% in compression and flexural strength. This approach imparts enhanced flexibility, resistance to corrosion, ease of execution, and cost-effectiveness [34].
